Manhole Inspection Summary

Manhole # S21G__063MH

Location Address: **114 MOUNT ST**

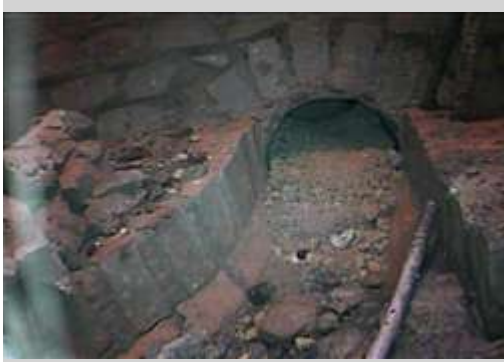
Comments **abandoned pipe at the i3 position**

abandoned pipe at i3

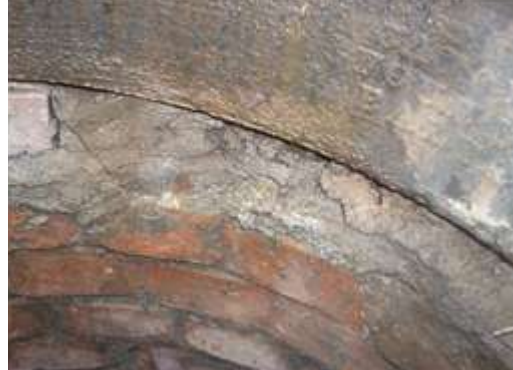
Defect 2

Condition: ☐ Sound ☐ Cracked ☐ Root Intrusion ☐ Loose Brick ☒ **Deteriorated**

DETERIORATED CHIMNEY

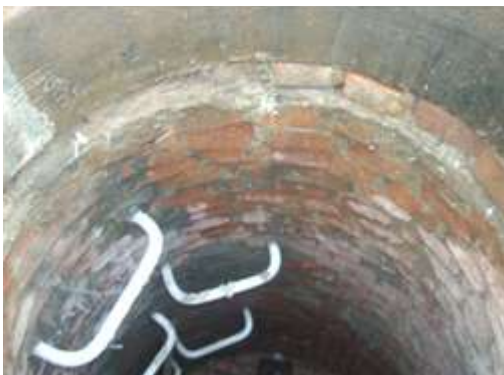
Defect 1

Infiltration: ☐ None ☒ **Joint** ☐ Cracks ☐ Mortar ☐ Roots ☐ Wall

INFILTRATION OF THE JOINT

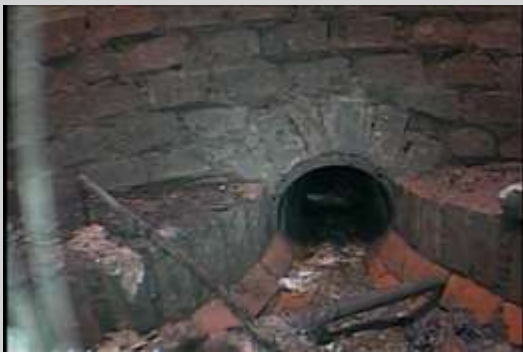
12 O'Clock Outflow

8 in. Circular Gravity Sewer
Pipe Out @ 12 O'Clock

Pipe Height: **8.4** (in.) Rod and Bar (Angled)
Pipe Material: **Clay** ☐ Pipe Lined
Invert Depth: **9.56** (ft.) Flow Characteristics: **Slow**
Deposits: ☐ None ☐ Mud ☐ Sludge ☒ **Debris** ☐ Grease
Silt Depth: **1** (in.) Deposits Extent: **Light**
Infiltration: **None** Pipe Seal Cond: **Sound**

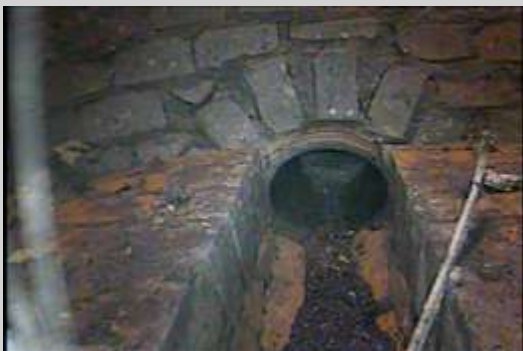
6 O'Clock Inflow

6 in. Circular Gravity Sewer
Pipe In @ 6 O'Clock

Pipe Height: **6** (in.) Rod and Bar (Angled)
Pipe Material: **Clay** ☐ Pipe Lined
Invert Depth: **9.09** (ft.) Flow Characteristics: **None**
Deposits: ☐ None ☐ Mud ☐ Sludge ☒ **Debris** ☐ Grease
Silt Depth: **1** (in.) Deposits Extent: **Light**
Infiltration: **None** Pipe Seal Cond: **Sound**

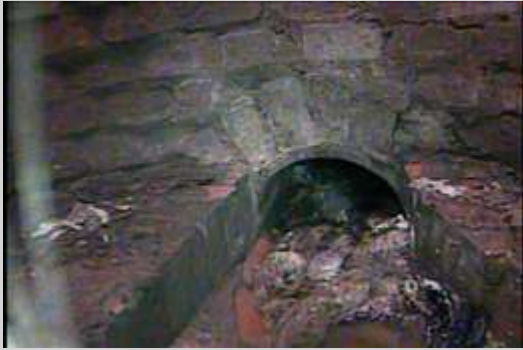
9 O'Clock Inflow

Deposits: ☐ None ☐ Mud ☐ Sludge ☒ **Debris** ☐ Grease

Silt Depth: **3** (in.) Deposits Extent: **Medium**
